## Troubleshooting and Maintaining Sloan CROWN II® & CROWN® Flushometers

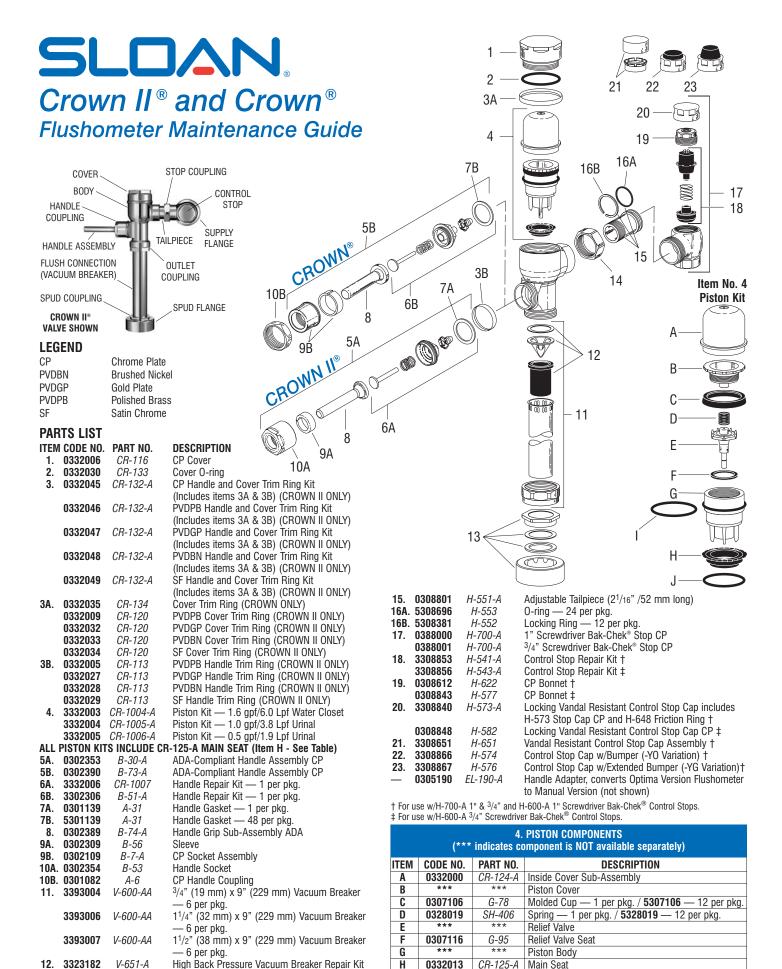
Filter O-ring

3/4" (19 mm) Spud Coupling Assembly

11/4" (32 mm) Spud Coupling Assembly

11/2" (38 mm) Spud Coupling Assembly

Stop Coupling
