# Braukmann EA79 Industrial Air Vent

## PRODUCT DATA

The EA79 Industrial Air Vent purges air from high pressure mains and equipment in hot or cold closed water systems.

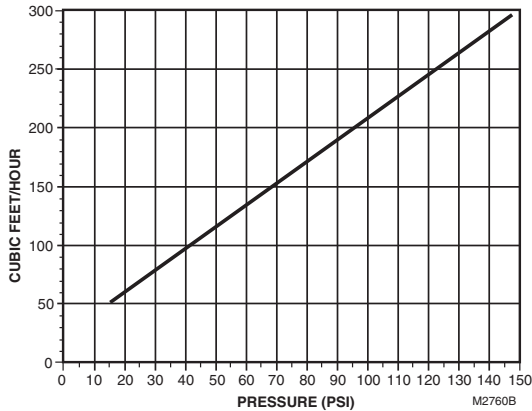
Fig. 2. EA79 flow capacities, with leakage guard cap.

NOTE: Capacity indicated is for device with leakage guard cap correctly installed and operational. Additional capacity may be obtained by removing the leakage guard cap and installing a connection between the vent discharge and drain using Q122A1001 Safe Waste Connector.

**Capacities:** Refer to Fig. 2

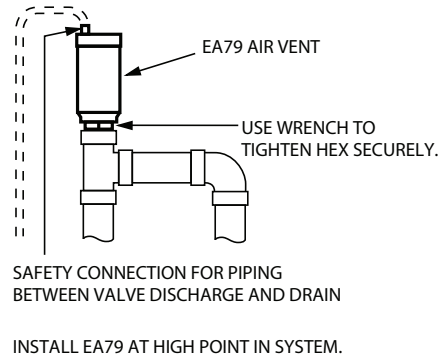
M6098

Fig. 3. Install EA122A at high point in system.

Install the EA79 on the positive side of the circulator pump at the point where air will accumulate. This is usually the high point of the supply or the return main in the system as shown in Fig. 3.

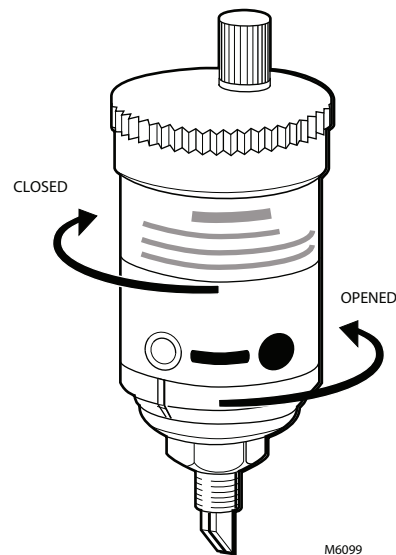
M6099

Fig. 4. Turn vent body counterclockwise to open or clockwise to close.

Opening the air vent (turning valve body counterclockwise) exposes the EA79 to the system. Water and air may enter the vent chamber. The float will fall through any air in the chamber. This opens the vent seat.

If the vent seat remains open, water will rise through the vent and cause the swelling disks inside the red cap to close off the vent. Closing the air vent (turning valve body clockwise) isolates the EA79 from the system, allowing service.

1. Turn the vent body clockwise to the closed position, isolating the vent from the system. See Fig. 4.
2. Remove the float assembly by unscrewing the outer ring at the top of the body and lifting up the black cover assembly. See Fig. 5.
3. Carefully clean any dirt or debris from the seat area.
