Regal® Flushometer

NOTE: Also for use with Regal® XL
(Since mid-2010)

The repair kits and parts listed on this page are designed to service all Sloan diaphragm type flushometers, including those manufactured for low consumption (LC) usage.

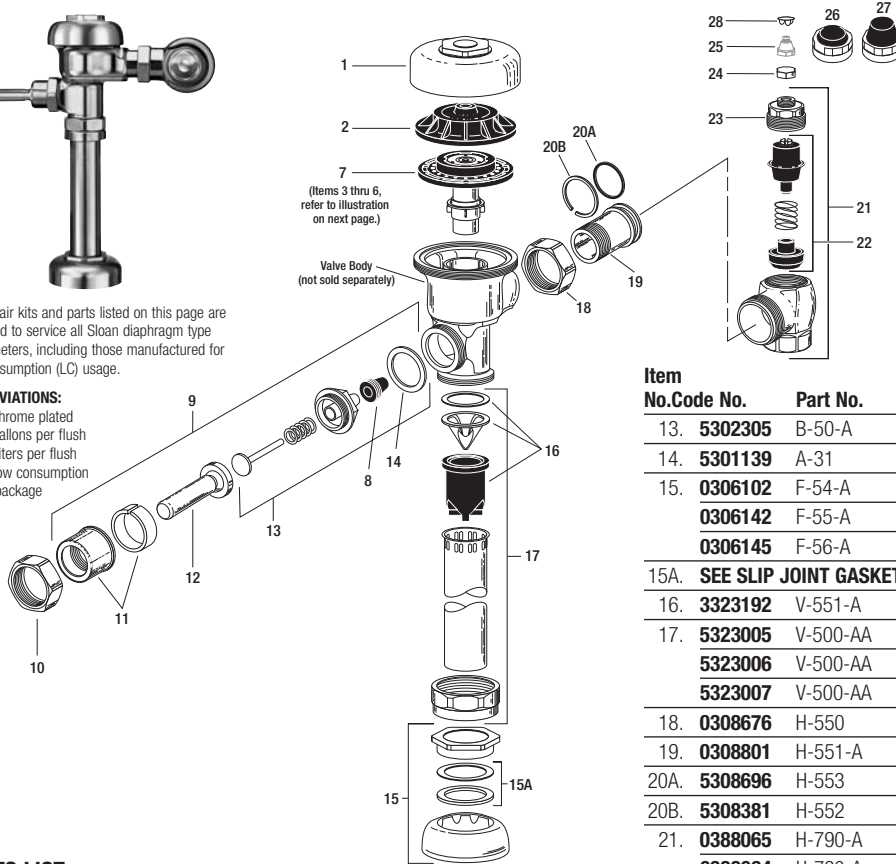
PARTS LIST

Item No.	Code No.	Part No.	Description
1.	0317004	R-10	CP Cover
	—	R-10-HE	CP High Efficiency Cover
2.	0301168	A-71	Inside Cover
SEE ITEMS 3A THROUGH 6E IN CHART ON NEXT PAGE			
3A.	5301058	A-19-AC	Relief Valve, White (Closet) – 12 per package
3B.	5301059	A-19-AU	Relief Valve, Black (Urinal) – 12 per package
3C.	5301211	A-19-ALC	Relief Valve, Green (Closet/Urinal-LC) – 12 per package
3D.	0301143	A-19-AL	Relief Valve, Blue (9 Liter Closet) – 12 per package

4.	5301111	A-15-A	Disc – for all Inside Parts Kits – 12 per package
5.	5301188	A-156-A	Diaphragm – for all Inside Parts Kits – 12 per package
6A.	5301236	A-163-A	Guide Assembly 4.5 gpf/17.0 Lpf Closet & 1.5 gpf/5.7 Lpf Urinal – 12 per package
6B.	5301032	A-152-A	Guide Assembly 3.5 gpf/13.2 Lpf Closet – 12 per package
6C.	5301031	A-151-A	Guide Assembly 1.6 gpf/6.0 Lpf LC Closet – 12 per package
6D.	5301155	A-155-A	Guide Assembly 1.0 gpf/3.8 Lpf LC Urinal – 12 per package
6E.	5301157	A-157-A	Guide Assembly 0.5 gpf/1.9 Lpf Urinal – 12 per package

7.	SEE INSIDE PARTS KITS CHART ON NEXT PAGE		
8.	5302297	B-39	Seal – 12 per package
9.	5302279	B-32-A	CP Handle Assembly – 6 per package
	0302390	B-73-A	CP Handicap Handle Assembly (ADA Compliant)

10.	0301082	A-6	CP Handle Coupling
11.	0302109	B-7-A	CP Socket Assembly
12.	5302274	B-32	CP Handle Grip – 12 per package
	0302389	B-74-A	CP Handicap Handle Grip (ADA Compliant)

Item No.	Code No.	Part No.	Description
13.	5302305	B-50-A	Handle Repair Kit – 6 per package
14.	5301139	A-31	Handle Gasket – 48 per package
15.	0306102	F-54-A	3/4" CP Spud Coupling Assembly
	0306142	F-55-A	1-1/4" CP Spud Coupling Assembly
	0306145	F-56-A	1-1/2" CP Spud Coupling Assembly
15A.	SEE SLIP JOINT GASKETS AND RINGS TABLE BELOW

16.	3323192	V-551-A	Vacuum Breaker Repair Kit
17.	5323005	V-500-AA	3/4" x 9" CP Vacuum Breaker – 6 per package
	5323006	V-500-AA	1-1/4" x 9" CP Vacuum Breaker – 6 per package
	5323007	V-500-AA	1-1/2" x 9" CP Vacuum Breaker – 6 per package

18.	0308676	H-550	CP Stop Coupling †
19.	0308801	H-551-A	CP Adjustable Tailpiece 2-1/16" long †
20A.	5308696	H-553	O-ring – 24 per package
20B.	5308381	H-552	Locking ring – 12 per package

21.	0388065	H-790-A	1" Screwdriver Bak-Chek® Stop CP – complete
	0388064	H-790-A	3/4" Screwdriver Bak-Chek® Stop CP – complete
	0388029	H-740-A	1" Screwdriver Bak-Chek® Stop CP – OBSOLETE
	0388031	H-740-A	3/4" Screwdriver Bak-Chek® Stop CP – OBSOLETE

22.	3308853	H-541-ASD	1" Control Stop Repair Kit *
	3308856	H-543-ASD	3/4" Control Stop Repair Kit **
23.	0308612	H-622	CP Bonnet (Current Regal)
	0308991	H-639	CP Bonnet – Pre 2010 Regal Stops*
	0308601	H-538	CP Bonnet ** – OBSOLETE

24.	5388001	H-1012-A	CP Cap – 6 per package VP
25.	5310034	J-2/J-7	Bumper Assembly – 6 per package – OBSOLETE
26.	3308866	H-574	Stop Cap, chrome plated with Seat Bumper (-YO)

27.	3308867	H-576	Stop Cap, chrome plated with Extended Seat Bumper (-YG)
28.	5388002	H-528	Hole Plug

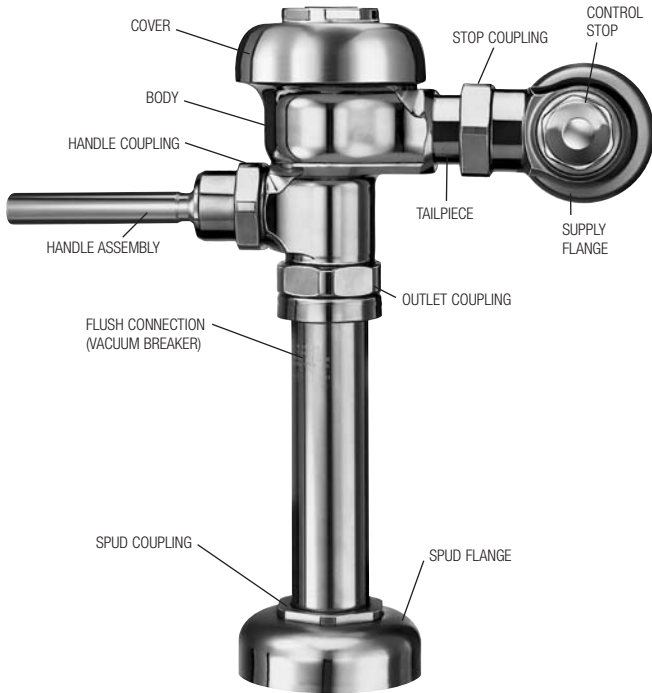
Refer to Parts List. Includes Items 7, 13, 16 & 20

Code No.	Part No.	Description
3317001	R-1001-A	Rebuild Kit (4.5 gpf/17.0 Lpf) Closet/Service Sink
3317002	R-1002-A	Rebuild Kit (1.5 gpf/5.7 Lpf) Urinal
3317003	R-1003-A	Rebuild Kit (3.5 gpf/13.2 Lpf) Closet
3317004	R-1004-A	Rebuild Kit (1.6 gpf/6.0 Lpf) Closet
3317005	R-1005-A	Rebuild Kit (1.0 gpf/3.8 Lpf) LC Urinal
3317011	R-1011-A	Rebuild Kit (0.5 gpf/1.9 Lpf) Urinal
3317012	R-1012-A	Rebuild Kit (2.4 gpf/9.0 Lpf) Closet

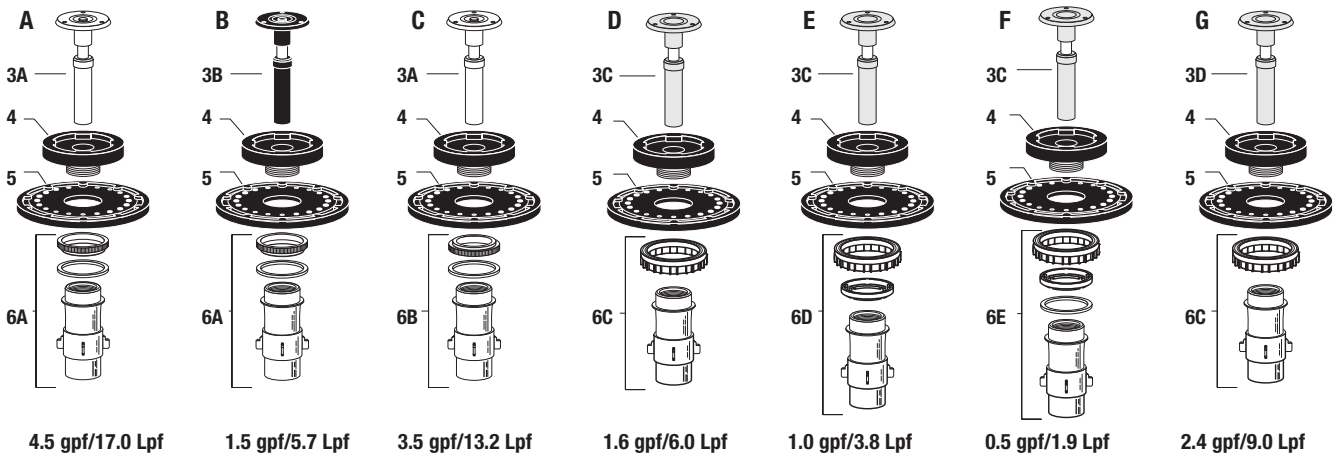
ITEM 7. INSIDE PARTS COMPONENTS (SEE ILLUSTRATIONS BELOW)

ITEM 7. INSIDE PARTS KITS (SEE ILLUSTRATIONS BELOW)

Item No.	Code No.	Part No.	Application
A.	3301036	A-36-A	4.5 gpf/17.0 Lpf - Closet
B.	3301037	A-37-A	1.5 gpf/5.7 Lpf - Urinal
C.	3301038	A-38-A	3.5 gpf/13.2 Lpf - Closet
D.	3301041	A-41-A	1.6 gpf/6.0 Lpf - Closet
E.	3301044	A-42-A	1.0 gpf/3.8 Lpf - Urinal
F.	3301081	A-43-A	0.5 gpf/1.9 Lpf - Urinal
G.	3301024	A-44-A	2.4 gpf/9.0 Lpf - Closet

Item No.	Code No.	Part No.	Description
3A.	5301058	A-19-AC	Relief Valve, White (Closet) – 12 per pkg.
3B.	5301059	A-19-AU	Relief Valve, Black (Urinal) – 12 per pkg.
3C.	5301211	A-19-ALC	Relief Valve, Green (Closet/Urinal-LC) – 12 per pkg.
3D.	0301143	A-19-AL	Relief Valve, Blue (9 Liter Closet) – 12 per pkg.
4.	5301111	A-15-A	Disc – for all Inside Parts Kits – 12 per pkg.
5.	5301188	A-156-A	Diaphragm – for all Inside Parts Kits – 12 per pkg.
6A.	5301236	A-163-A	Guide Assembly 4.5 gpf/17.0 Lpf Closet & 1.5 gpf/5.7 Lpf Urinal – 12 per package
6B.	5301032	A-152-A	Guide Assembly 3.5 gpf/13.2 Lpf Closet – 12 per package
6C.	5301031	A-151-A	Guide Assembly 1.6 gpf/6.0 Lpf LC Closet – 12 per package
6D.	5301155	A-155-A	Guide Assembly 1.0 gpf/3.8 Lpf LC Urinal – 12 per package
6E.	5301157	A-157-A	Guide Assembly 0.5 gpf/1.9 Lpf Urinal – 12 per package
