## PARTS BREAKDOWN

| ECN: 5527 | | FV | | FV | | H1001.8/H1001.8HPS | | 0002080246 | |

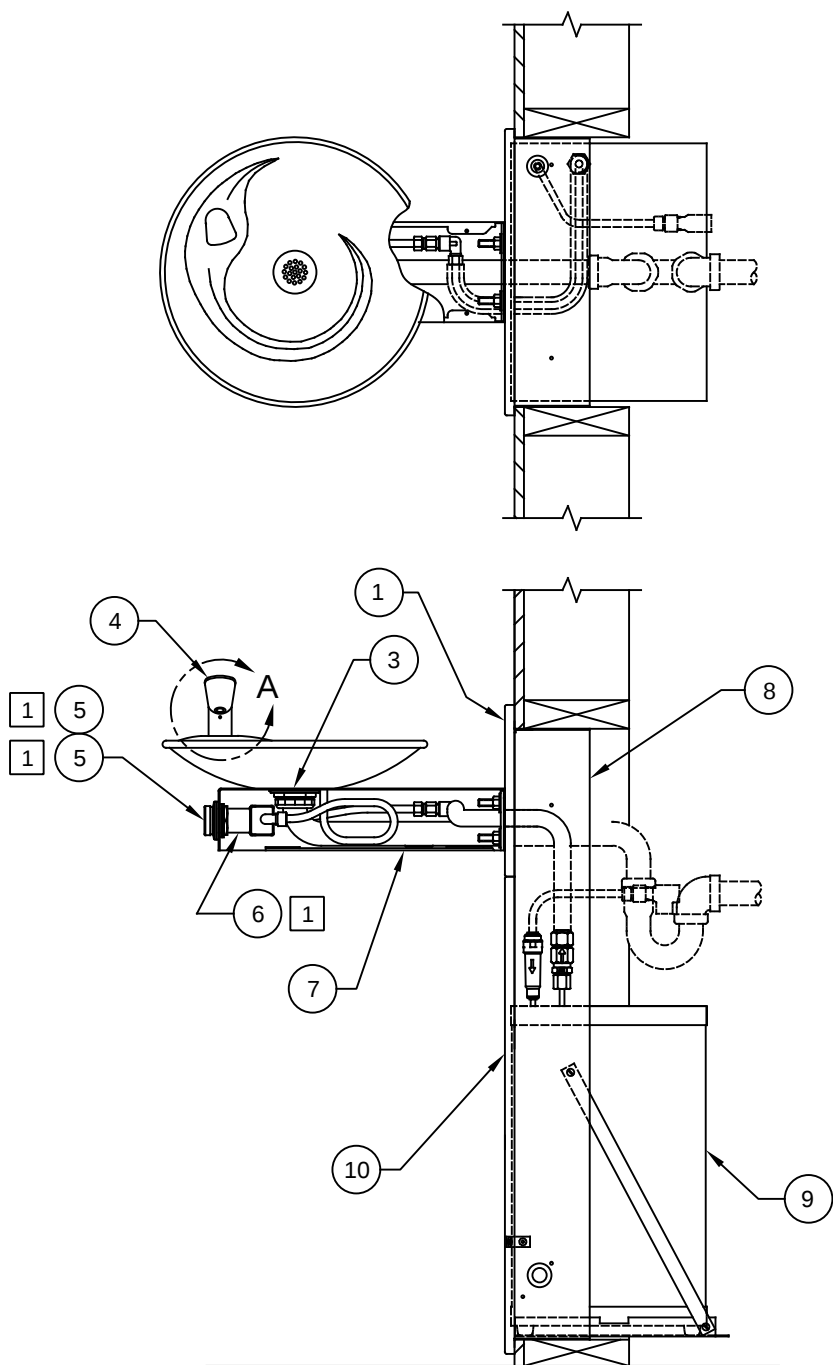
- 1 5874PBF (ITEM 6) INCLUDES VRK5874 CARTRIDGE ASSEMBLY (ITEM 12) AND PBA6 FLANGED PUSH BUTTON (ITEM 5).

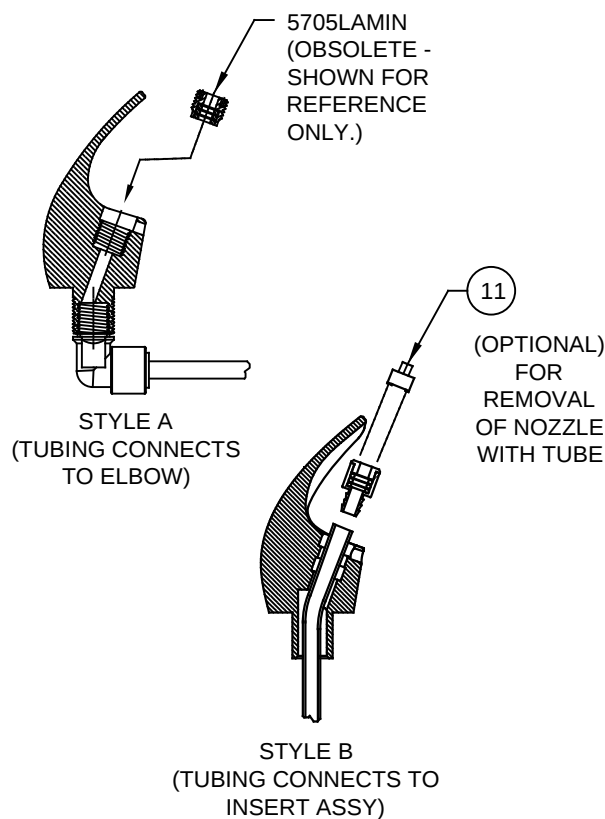
FOUNTAIN COULD HAVE EITHER STYLE  
DETAIL A  
ROTATE 90° INTO VIEW  
DETAIL OF ITEM 5705
