DRINKING FOUNTAIN VALVE

INSTALLATION INSTRUCTIONS FOR 5874PBF.

INSTALLATION INSTRUCTIONS FOR 5874PB.

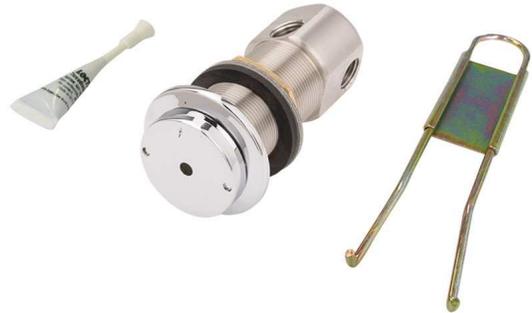
The push-button activated valve offers the only all stainless steel valve body that is machined out of solid bar stock, is fully serviceable through the front of the push button assembly offering access to the water control cartridge and integral water supply strainer, and with front access to the water stream height adjustment for easy maintenance without having to remove the valve. Operating pressure range of 30 to 90 psi (2.1 to 6.2 bar).

All chrome plated brass push button resists vandalism by allowing it to spin without unscrewing.

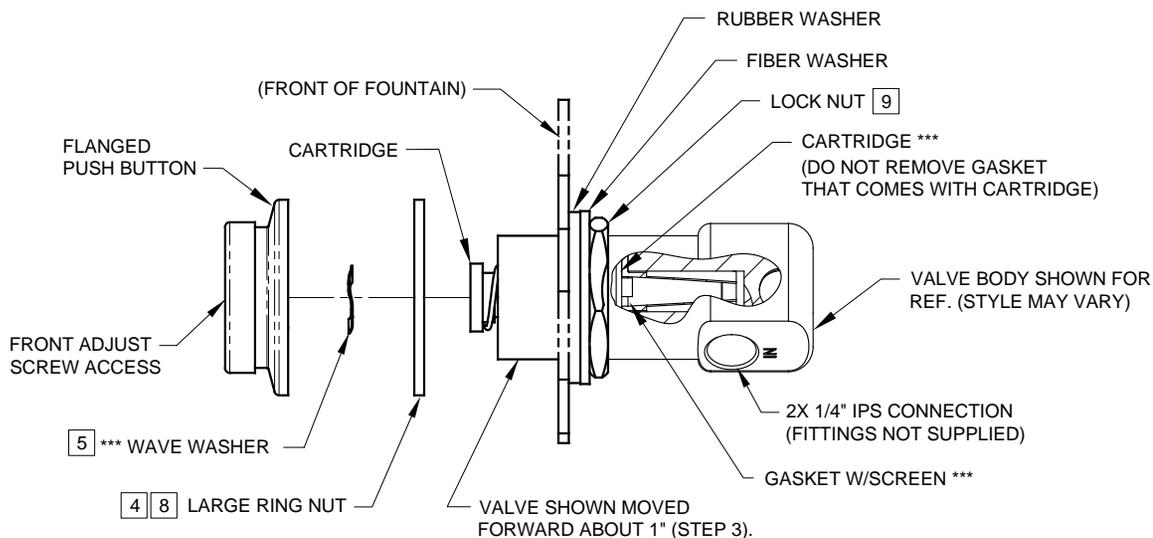
ASSEMBLED 5874PBF
(FLUSH MOUNT APPLICATION)

*** MODEL VRK5874 & VRK5874HF- VALVE REPAIR KITS INCLUDE THESE ITEMS

- 1) FOLLOW INSTRUCTIONS CAREFULLY ON O&M MANUAL (PAGE 2 OF 6) WHEN REMOVING OLD VALVE. **NOTE: SEE PARTS BREAKDOWN (PAGE 4 OF 6) FOR ADDITIONAL NOTES.**

- 2) VERIFY THAT LOCK NUT, FIBER, AND RUBBER WASHERS ARE POSITIONED SLIGHTLY PAST MIDWAY OF THREADS ON NEW VALVE BODY.
- 3) INSERT VALVE INTO BRACKET FROM INSIDE AND PUSH FORWARD ABOUT 1".

- 4) THREAD LARGE RING NUT ONTO VALVE BODY, APPROXIMATELY 1" INTO VALVE.
- 5) PLACE WAVE WASHER INSIDE OF FLANGED PUSH BUTTON ASSEMBLY (**MUST BE IN PLACE**).

- 6) APPLY ONE (1) DOT OF LOCTITE 222MS, ON THE FEMALE THREADS OF BUTTON ASSEMBLY LEAVING THE FIRST AND LAST THREADS FREE. (FIGURE 1). **CAUTION: EXCESS LOCTITE CAN CAUSE THREADS TO LOCK VERY TIGHTLY, MAKING REPAIRS DIFFICULT.**

- **7) THREAD FLANGED PUSH BUTTON ASSEMBLY ON VALVE UNTIL WAVE WASHER MAKES SLIGHT CONTACT WITH STEM OF CARTRIDGE. **CAUTION: DO NOT HAND-TIGHTEN.**
- 8) UNTHREAD RING NUT FORWARD UNTIL IT STOPS FLUSH WITH PUSH BUTTON ASSEMBLY.

- 9) PUSH VALVE BACK TOWARD THE INSIDE OF BRACKET AND TIGHTEN LOCKNUT (SEE ILLUSTRATION ABOVE).
- 10) TIGHTEN PUSH BUTTON ASSEMBLY USING UNIVERSAL SPANNER WRENCH PROVIDED.

** OVERTIGHTENING WILL PRE-ACTUATE VALVE AND CAUSE WEEPAGE, WHILE NOT ENOUGH CONTACT BETWEEN WAVE WASHER AND STEM CAN CAUSE A LOW FLOW CONDITION.

* 6 APPLY 1 DOT OF LOCTITE 222MS (WHERE SHOWN)

THIS VALVE IS PRESSURE COMPENSATING. BE SURE TO REMOVE ANY EXISTING FLOW CONTROL DEVICES. (MAY BE PRESENT IN FITTING OR SPUD).

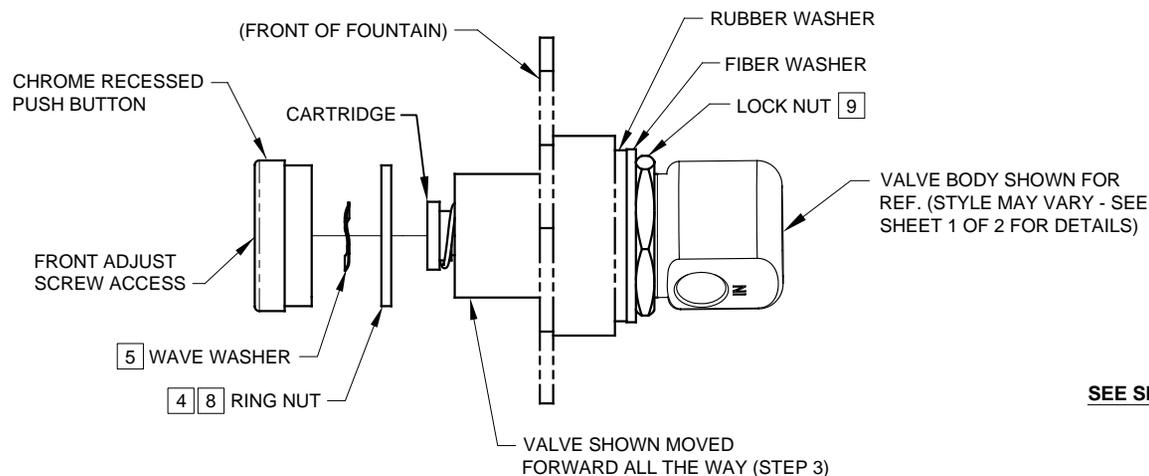
ASSEMBLED 5874PB
(RECESSED MOUNT APPLICATION)

- 1) FOLLOW INSTRUCTIONS CAREFULLY ON O&M MANUAL (PAGE 2 OF 6) WHEN REMOVING OLD VALVE. **NOTE: SEE PARTS BREAKDOWN (PAGE 4 OF 6) FOR ADDITIONAL NOTES.**

- 2) VERIFY THAT LOCK NUT, FIBER WASHER, AND RUBBER WASHERS ARE POSITIONED TOWARD BOTTOM END OF THREADS ON NEW VALVE BODY.
 - 3) INSERT VALVE INTO BRACKET FROM INSIDE, AND PUSH ALL THE WAY FORWARD (SEE ILLUSTRATION ABOVE).

- 4) THREAD RING NUT ONTO VALVE BODY, AS FAR IN AS POSSIBLE, TOWARD FRONT OF FOUNTAIN. **NOTE: IF REPLACING A 5871 OR 5872 SERIES VALVE, YOU MAY HAVE TO CONTACT HAWS TECHNICAL SUPPORT.**

- 5) PLACE WAVE WASHER INSIDE OF PUSH BUTTON ASSEMBLY (**MUST BE IN PLACE**).
 - 6) APPLY ONE (1) DOT OF LOCTITE 222MS, ON THE FEMALE THREADS OF BUTTON ASSEMBLY LEAVING THE FIRST AND LAST THREADS FREE. (FIGURE 1). **CAUTION: EXCESS LOCTITE CAN CAUSE THREADS TO LOCK VERY TIGHTLY, MAKING REPAIRS DIFFICULT.**

- **7) THREAD PUSH BUTTON ASSEMBLY ON VALVE UNTIL WAVE WASHER MAKES SLIGHT CONTACT WITH STEM OF CARTRIDGE. **CAUTION: DO NOT HAND-TIGHTEN.**
 - 8) UNTHREAD RING NUT FORWARD UNTIL IT STOPS FLUSH WITH PUSH BUTTON ASSEMBLY.

- 9) PUSH VALVE BACK TOWARD THE INSIDE OF BRACKET AND TIGHTEN LOCKNUT (SEE ILLUSTRATION ABOVE).
 - 10) TIGHTEN PUSH BUTTON ASSEMBLY USING UNIVERSAL SPANNER WRENCH PROVIDED.

- ** OVERTIGHTENING WILL PRE-ACTUATE VALVE AND CAUSE WEEPAGE, WHILE NOT ENOUGH CONTACT BETWEEN WAVE WASHER AND STEM CAN CAUSE A LOW FLOW CONDITION.

* 6 APPLY 1 DOT OF LOCTITE 222MS (WHERE SHOWN)

NOTE!
THIS VALVE IS PRESSURE COMPENSATING. BE SURE TO REMOVE ANY EXISTING FLOW CONTROL DEVICES. (MAY BE PRESENT IN FITTING OR SPUD).
