## **SERVICE PARTS LIST**

REVISED BULLETIN DATE Dec. 2012 M18 FUEL™ 1/2" Square Impact Wrench WIRING INSTRUCTION STARTING SERIAL NO 2655-20 CATALOG NO. **E55A** SEE PAGE 2

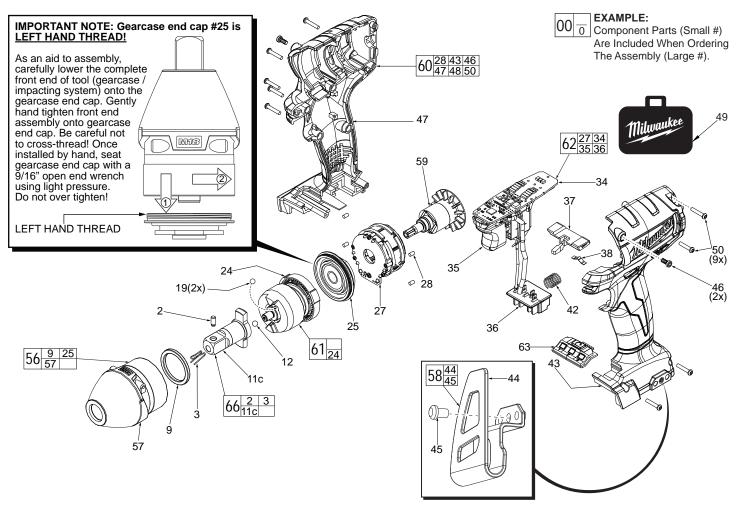
FIG.	PART NO.	DESCRIPTION OF PART N	O. REQ.
2	44-60-0012	Detent Pin	(1)
3	40-50-0112	Detent Spring	(1)
9	45-88-2653	Plastic Washer	(1)
11c		1/2" Square Anvil	(1)
12	02-02-1300	5mm Steel Ball	(1)
19	02-02-0180	4.7mm Steel Ball	(2)
24		Ring Gear	(1)
25	44-66-2653	Gearcase End Cap with Ball Bearing	(1)
27		Stator Assembly	(1)
28	45-30-2653	Rubber Slug	(4)
34		PCBA	(1)
35	23-66-2653	On-Off Switch	(1)
36		Terminal Block Assembly	(1)
37	45-24-2653	Fwd/Rev Shuttle	(1)
38	40-50-1135	Spring	(1)
42	40-50-1090	Spring	(1)
43		Left Handle Halve	(1)
44		Belt Hook	(1)
45	06-82-0130	6-32 x 5/16" Pan Hd. T-15 Machine Sc	cr (1)
46	06-82-2653	M3.5 x 8mm Pan Hd. Plastite Screw	(2)
47		Right Handle Halve	(1)
48	12-20-2653	Service Nameplate (Not Shown)	(1)
49	42-55-2653	Carrying Case	(1)
50	06-82-7236	4-20 x 5/8" Pan Hd. Plastite T-10 Scr	(9)
56	14-30-2656	Gearcase Assembly	(1)
57	28-50-2654	Front Gearcase	(1)
58	42-70-2653	Belt Clip Assembly	(1)

FIG.	PART NO.	DESCRIPTION OF PART	NO. REQ.
59	16-07-2654	Rotor Assembly	(1)
60	31-44-2653	Handle Assembly	(1)
61	14-30-0095	Impacting Assembly	(1)
62	14-20-2655	Electronics Assembly	(1)
63	45-24-2655	Speed Selector	(1)
66	42-06-0030	1/2" Square Anvil Assembly	(1)

## FIG. **LUBRICATION** (Type 'J' Grease, No. 49-08-4220):

- 11c Lightly coat front washer surface of anvil (11c) with grease.
- Lightly coat the I.D. of the ring gear (24) and the center of the planet gears of impacting assembly with grease. 24,61
- 57 Coat inside of bushing inside front gearcase with grease.
- 59 Coat pinion of rotor assembly (59) with grease.
