SERVICE PARTS LIST

BULLETIN NO.
54-49-0300

SPECIFY CATALOG NO. AND SERIAL NO. WHEN ORDERING PARTS		REVISED BULLETIN	DATE
M18™ Radio Charger			Dec. 2013
CATALOG NO.	2792-20	SERIAL NUMBER	F69A
			WIRING INSTRUCTION SEE PAGE 4

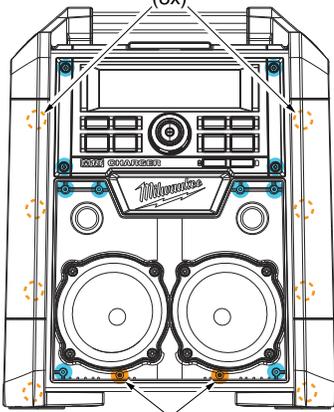
FRONT VIEW

Screws behind Left & Right Handles (8x)

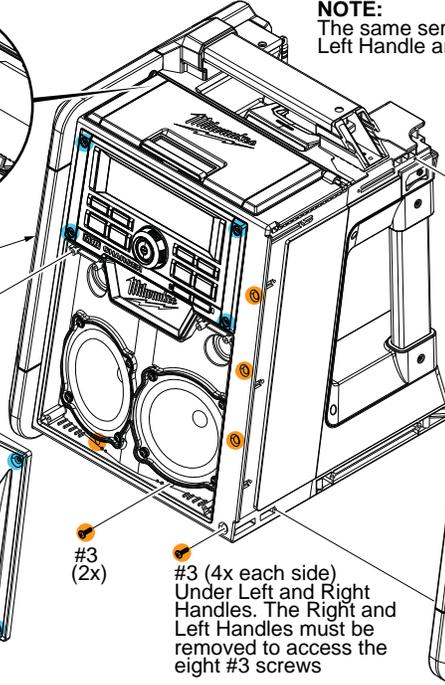
NOTE:
All fasteners indicated must be removed to gain access to the interior of the unit and servicing of the Charger and PCBA

The same series of screws that are used for the Left Handle are used on the Right Handle

#2 (1x each side) on back of Left and Right Handles

#2 (9x each side) on side of Left and Right Handles

Left Handle

#3 (2x)

#3 (4x each side) Under Left and Right Handles. The Right and Left Handles must be removed to access the eight #3 screws

#1 (1x each side) on bottom of Left and Right Handles

#2 (3x each side) on bottom of Left and Right Handles

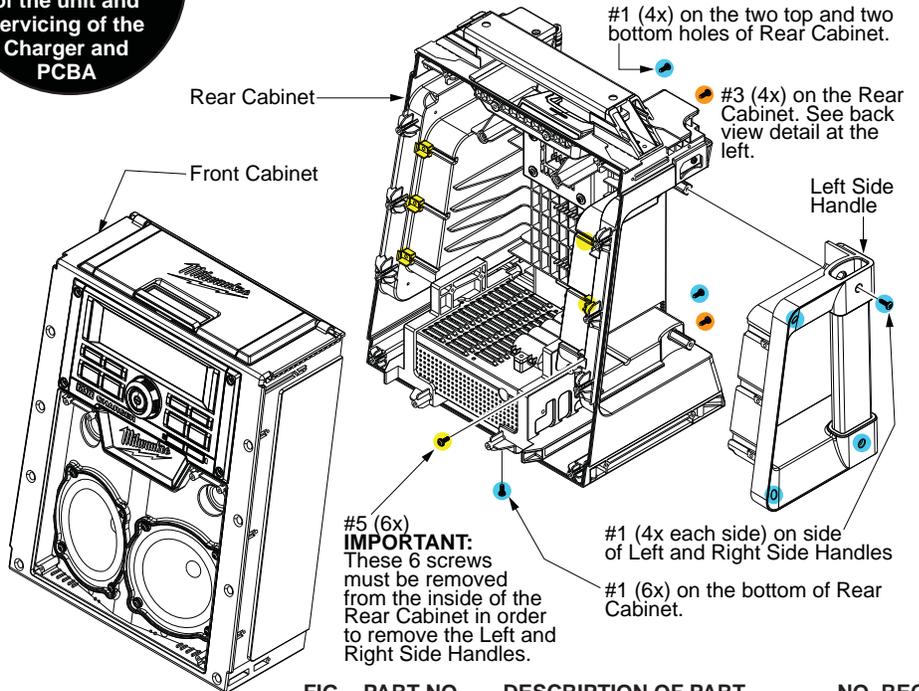
#1 (4x) on the two top and two bottom holes of Rear Cabinet.

#3 (4x) on the Rear Cabinet. See back view detail at the left.

Left Side Handle

#5 (6x) **IMPORTANT:** These 6 screws must be removed from the inside of the Rear Cabinet in order to remove the Left and Right Side Handles.

#1 (4x each side) on side of Left and Right Side Handles
#1 (6x) on the bottom of Rear Cabinet.
