## Z1321 ECOLOTROL WALL HYDRANT WITH CERAMIC DISC Parts Assembly, Parts List, and Operating Rod Assemblies

## Z1321 ECOLOTROL WALL HYDRANT WITH CERAMIC DISC Troubleshooting Guide

## Z1321 ECOLOTROL WALL HYDRANT WITH CERAMIC DISC Service Guide

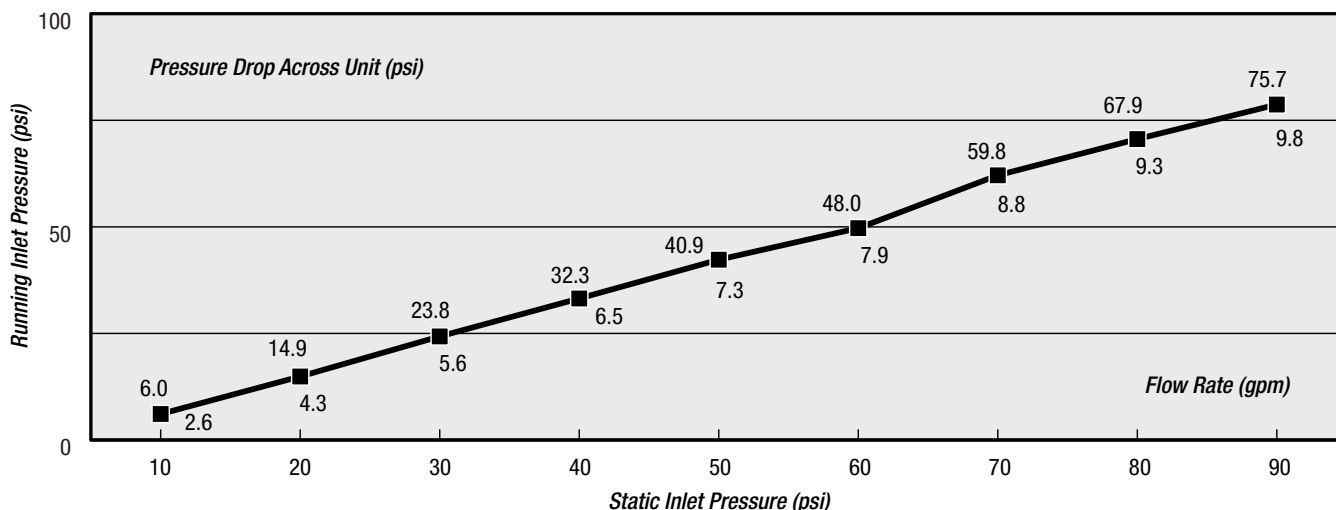
Z1321 Ecolotrol Wall Hydrant with Ceramic Disc – 3/4" Hose Connection				
Static Pressure (psi)	Running Inlet Pressure (psi)	Running Outlet Pressure (psi)	Flow Rate (gpm)	Pressure Drop Across Unit (psi)
10	6.1	0.0	2.6	6.0
20	14.9	0.0	4.3	14.9
30	24.3	0.5	5.6	23.8
40	33.2	0.9	6.5	32.3
50	42.3	1.4	7.3	40.9
60	49.7	1.7	7.9	48.0
70	62.1	2.3	8.8	59.8
80	70.6	2.7	9.3	67.9
90	78.7	3.1	9.8	75.7
